FACILITY CONDITION ASSESSMENT

FACILITY CONDITION ASSESSMENT
OF
LA BALLONA ELEMENTARY SCHOOL
10915 WASHINGTON BOULEVARD
CULVER CITY, CALIFORNIA 90230

January 25, 2019

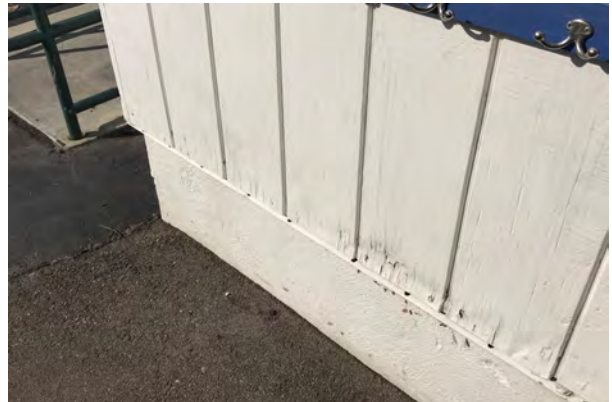
#10	TEXTURED PLYWOOD SIDING WATER DAMAGE
-----	--------------------------------------

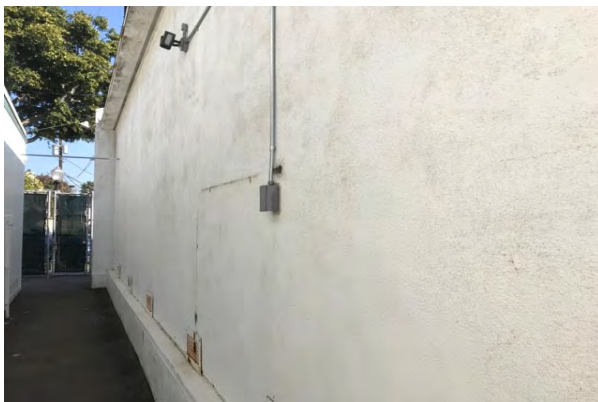
Exterior Wall in Poor condition.
 Painted Surface, 1-2 Stories (Uniformat Code: B2011)
 Building 02 & 03 La Ballona ES Building Exterior
 Recommendation: **Prep & Paint** in 2020.
 Peeling handrail and wall paint coating.
 AssetCALC ID: 1149404

#11	EXTERIOR WALL PAINT
-----	---------------------

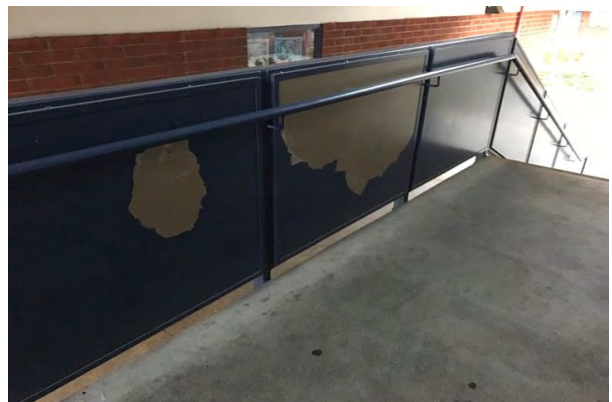
#12	PEELED PAINT
-----	--------------

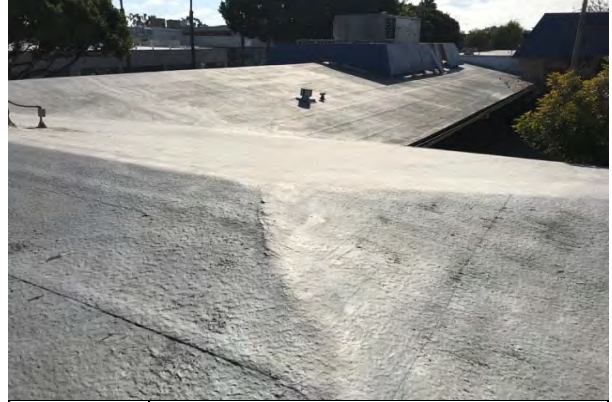
Roof in Poor condition.
 Built-Up (Uniformat Code: B3011)
 Buildings 1, 4 & 5 La Ballona ES Roof
 Recommendation: **Replace** in 2020.
 Exceedingly aged and cracking roof coating, evidence of multiple leaks seen below.
 AssetCALC ID: 1149381

#20	BUILDINGS 1, 4 AND 5 BUILT-UP ROOFING
-----	---------------------------------------

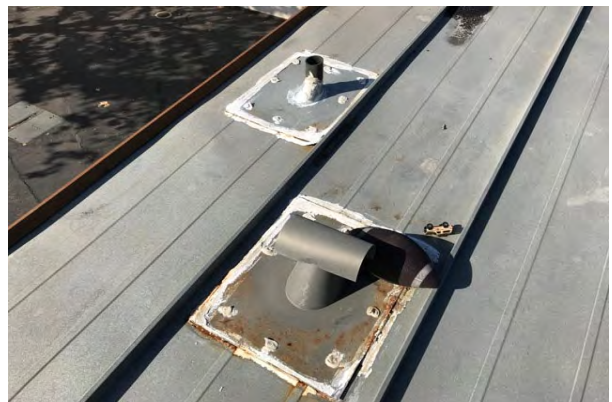
Roof in Poor condition.
 Metal (Uniformat Code: B3011)
 Portables 07-09, 11-13 La Ballona ES Roof 12
 Recommendation: **Replace** in 2019.
 Flashing not sealed well at portable next to restrooms.
 AssetCALC ID: 1149468

#24	PORTABLE 12 DAMAGED FLASHING SEAL
-----	-----------------------------------

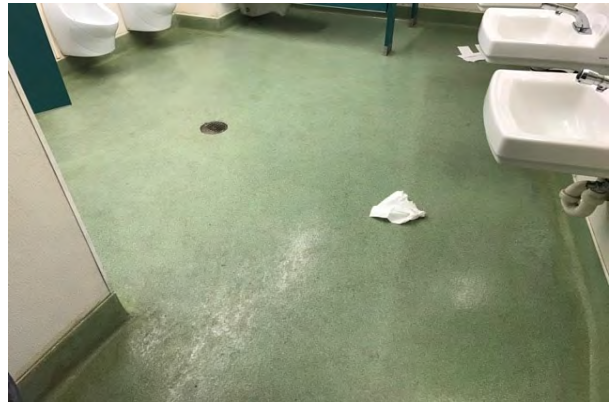
#34	EPOXY COATING
-----	---------------

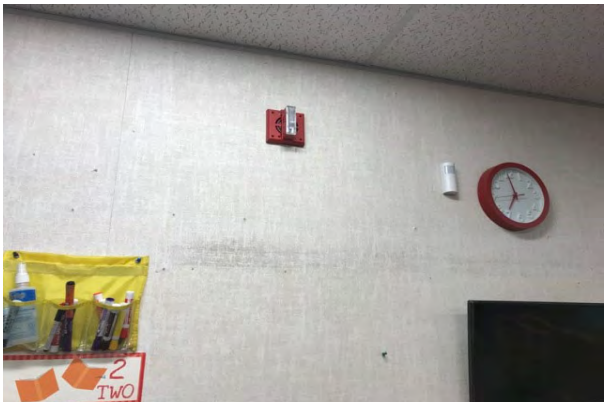
Fire Alarm System in Fair condition.

Equipment appears to have been installed in 1998. Although there are no known violations or issues it is recommended it be replaced to ensure reliable operation and access to replacement parts.

#60	FIRE ALARM
-----	------------

Recommendation: **Upgrade** in 2019.

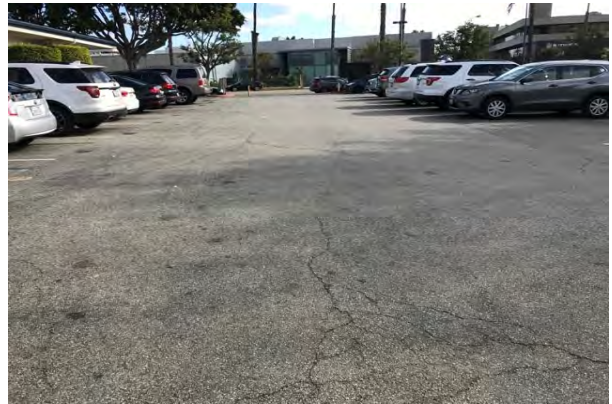
<p>Parking Lots in Poor condition. Asphalt Pavement (Uniformat Code: G2022) Site La Ballona ES Site Recommendation: Seal & Stripe in 2020. Worn seal coat and striping. AssetCALC ID: 1149414</p>	<p>Priority Score 87.0

#64	PARKING LOT
-----	-------------

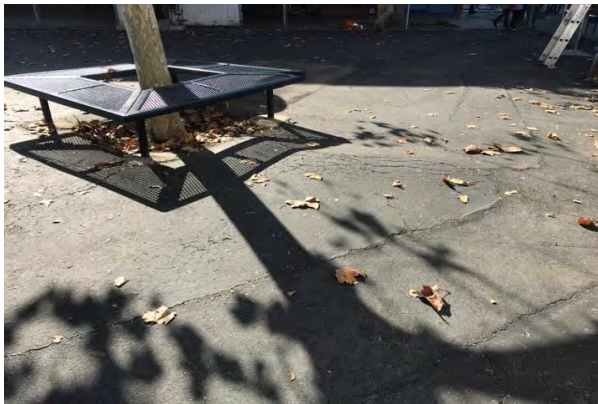
<p>Play Surfaces & Sports Courts in Poor condition. Asphalt (Uniformat Code: G2047) Site La Ballona ES Site Recommendation: Mill & Overlay in 2021. Lifting due to tree roots AssetCALC ID: 1149417</p>	<p>Priority Score 83.0

#65	LIFTING ASPHALT
-----	-----------------
