FACILITY CONDITION ASSESSMENT

FACILITY CONDITION ASSESSMENT
OF
LA BALLONA ELEMENTARY SCHOOL
10915 WASHINGTON BOULEVARD
CULVER CITY, CALIFORNIA 90230

January 25, 2019

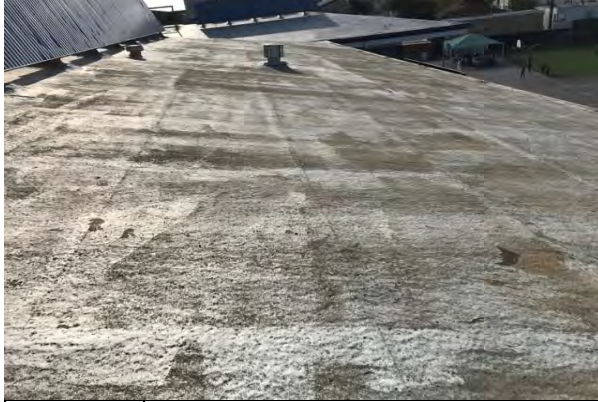
#19	BUILDING 3 BUILT-UP ROOF
-----	--------------------------

Roof in Poor condition.
 Built-Up (Uniformat Code: B3011)
 Building 02 & 03 La Ballona ES Building 3 Roof
 Recommendation: **Replace** in 2020.
 Coating is exceedingly aged and peeling.
 AssetCALC ID: 1149402

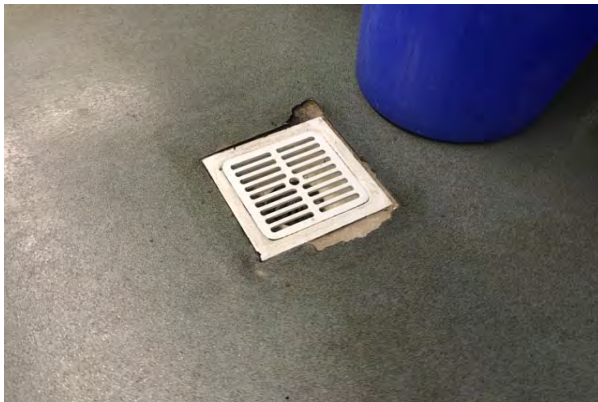
#35	CHIPPING EPOXY COATING
-----	------------------------
